Report on Gravestones

Lumbutts Methodist Chapel Graveyard

Our Ref: 24-035

3 October 2024

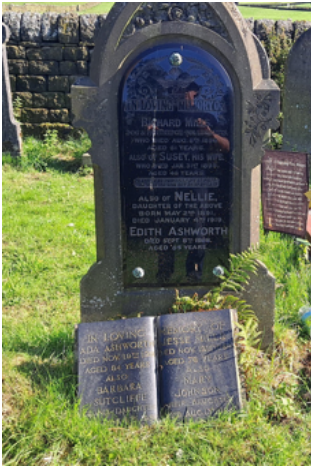
Lancet with black etched glass inset, also Book style ledger at base, grit stone with marble inset.	Bk.no.159, now full. In loving memory of Richard Mills	Loose in ground	Set further into ground one third for stability. The black glass memorial is high quality and fragile. It should remain above ground level. This monument is unsuitable for laying flat. The book style stone will need moving forward to avoid risk of damage to the glass should further settlement occur.

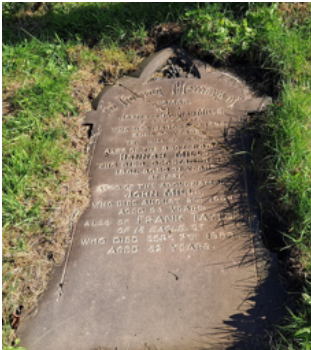
Ref	Image	Description	Part Inscription (identifier)	Condition	Recommendation to make safe*
Bk.no.183. Unmarked

Large stone lancet	owner John Mills	Laid flat on ground, face up	Considered safe. No action.
Bk.no. 196.

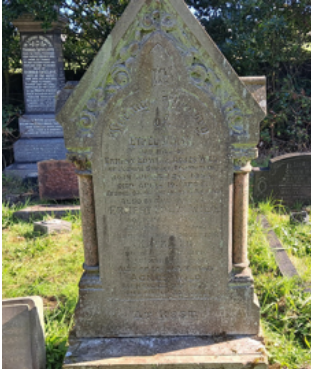
Sculpted lancet with marble side pillars.	In loving memory of Ethel Mary daughter of Ernest Edwin and Agnes Wild	Slightly loose on base	Could leave for now. Dependent on weathering (ice expansion in open joints), further work in likely to be identified in the near future.

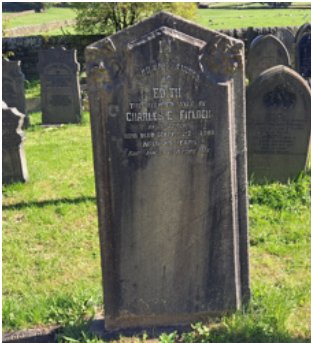
Ref	Image	Description	Part Inscription (identifier)	Condition	Recommendation to make safe*
G.bk.no.4 17.

Limestone ledger.	In loving memory of Edith the beloved wife of Charles E. Fielden	Movement in ground including plinth	Set in ground one third for stability or if impracticable laid down flat, face up.
Bk.no. 420 and 421.

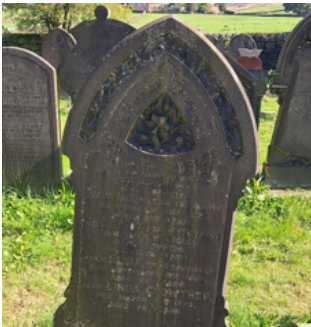
Gritstone lancet	In loving memory of William Crowther	Loose, sounds like in socket	Set in ground one third for stability or if impracticable laid down flat, face up.

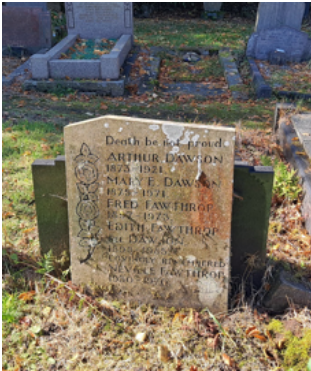
Ref	Image	Description	Part Inscription (identifier)	Condition	Recommendation to make safe*
Bk.no.845.

Upright ledger.	Arthur Dawson 1873 – 1921	Out of ground, leant against stone behind	Set in ground one third for stability or if impracticable laid down flat, face up.
Bk.no.891.

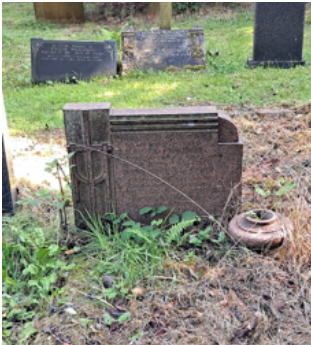
Red reconstituted marble pedestal with sidestones.	Treasured memories of my dear husband Samuel Fielden	Loose in ground	Lay flat within grave.

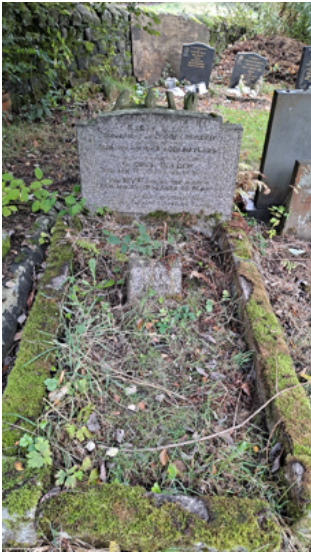
Ref	Image	Description	Part Inscription (identifier)	Condition	Recommendation to make safe*
Bk.no.997.

Granite upright ledger (vault).	In loving memory of Sarah Ellen beloved wife of George Holden	Loose, could fall forward	Lay flat within grave.
